# FoR News April 2019

## Restoration and Maintenance Special Report

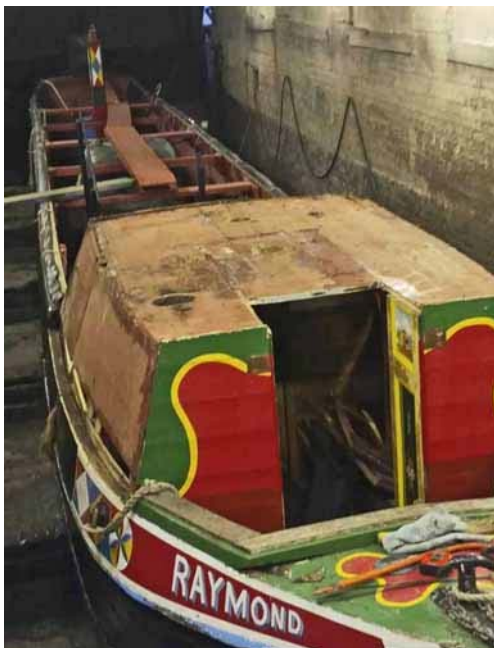
*Raymond* in Bulbourne dry dock, December 2016  
Picture: Jem Bates

In early December 2016, *Raymond* was taken to Bates Boatyard's dry dock at Bulbourne for boat builder Jem Bates to caulk the bottoms and investigate the state of the cabin. It turned out that the cabin panels were rotten to such an extent that the entire exterior of the cabin would have to be removed and rebuilt.

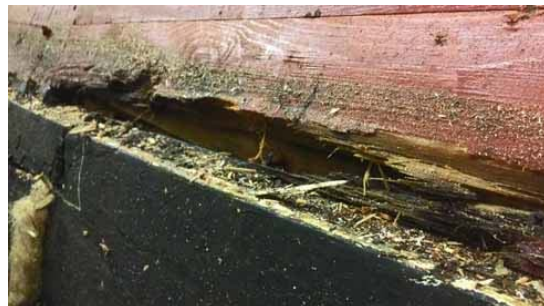
Rot in *Raymond's* cabin side, December 2016  
Picture: Jem Bates

The caulking was finished before Christmas. Then, immediately after New Year Jem Bates and his team set about the job of stripping back the cabin to the bare framework. And in doing so, they discovered that the root cause of the rot was water seeping between the top plank of the hull and the bottom of the cabin side, a problem that, we hope, Jem has solved by letting the new panels into a rebate cut into the top plank.

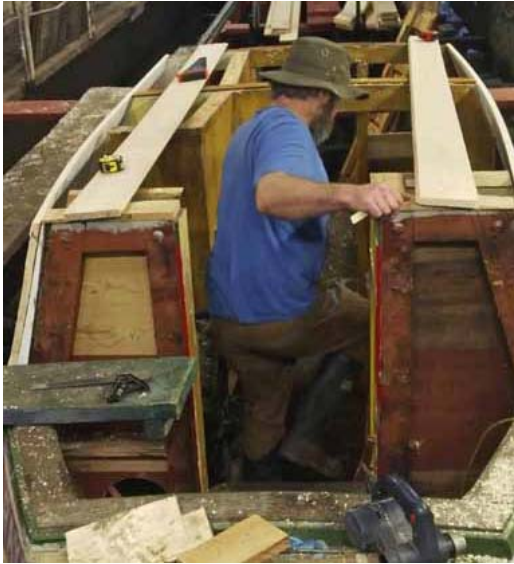
Jem Bates checks the work in progress, 11 Jan 2017

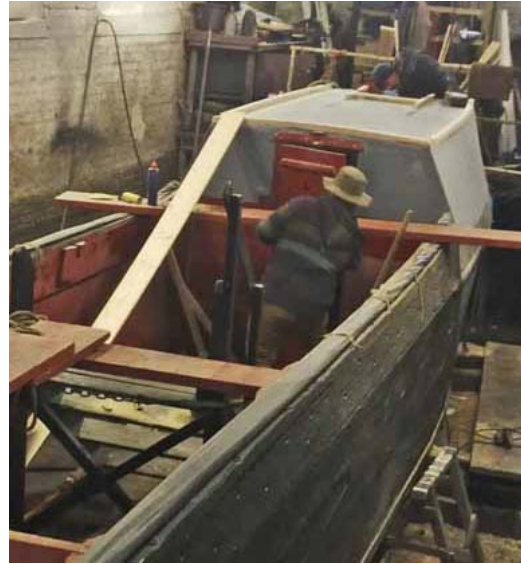
A week later and the cabin takes shape, 19 Jan 2017

The cabin rebuild was completed within four weeks and *Raymond* left the dry dock on 27 January.

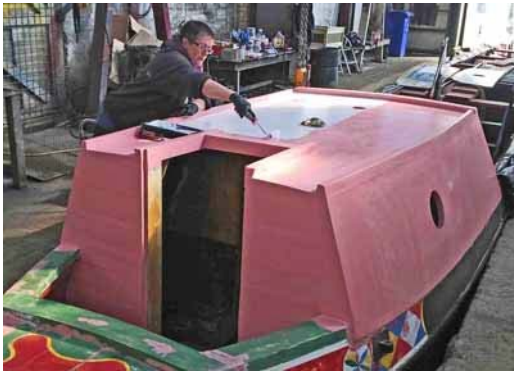
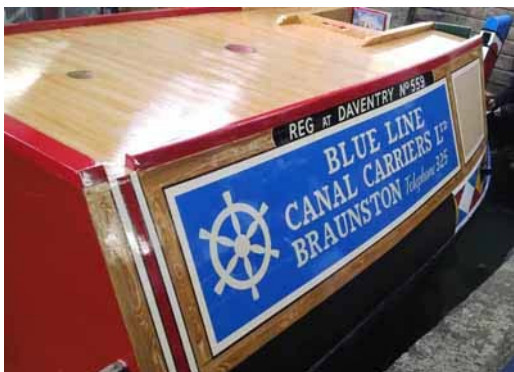
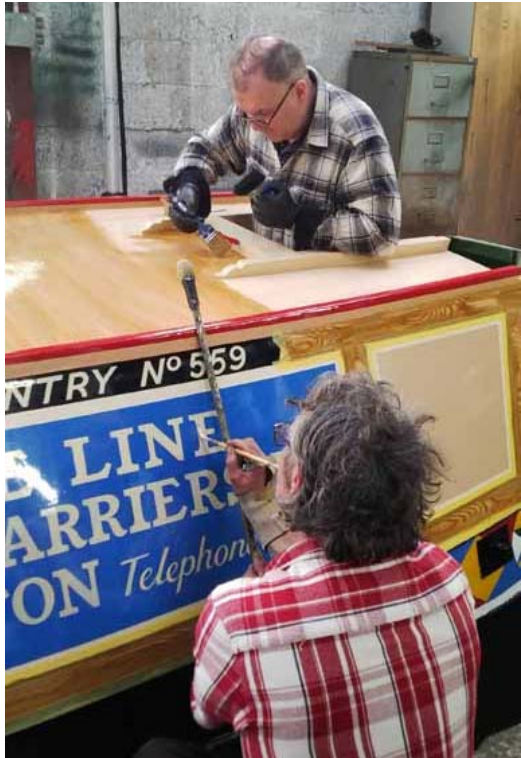
Top left: FoR's Caroline Brudenell undercoats the roof, 23 March 2017  
 Right: FoR's Peter Copeland scumbles the roof while Alan Baillie completes the lettering, 1 April 2017  
 Bottom left: the finished cabin, 1 April 2017

But once at Blisworth, *Raymond* spent the next two weeks in the paint dock where boat painter Jason Clarke and signwriter Alan Baillie, together with a little volunteer help, restored the dull grey cabin back to its former glory.

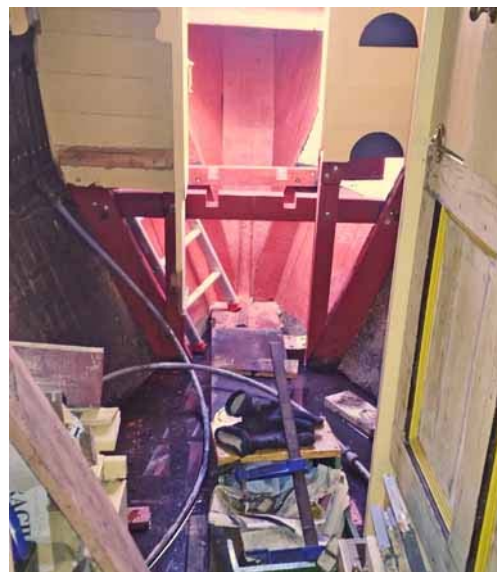
Before Christmas 2017, Pete Boyce moved *Raymond* up to his yard at Tess Wharf, opposite Braunston Turn. And, in early January, he began the job of removing the fitted furniture aft of the bed cupboard, stripping the sheering from the sides and taking out the rotten floorboards and the deck in the hatches, leaving the cabin an empty, and rather wet, void.

Raymond's cabin, 8 March 2018

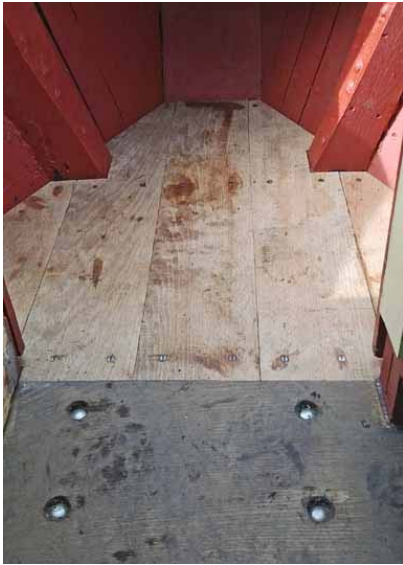
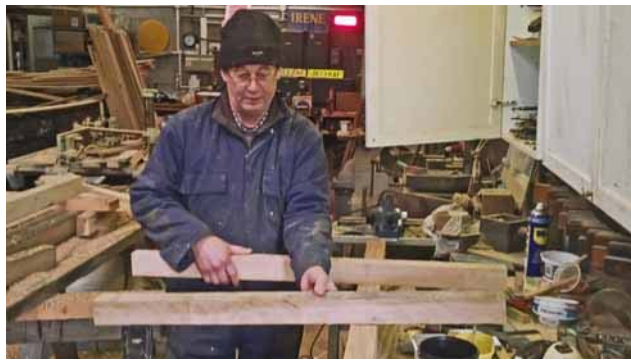
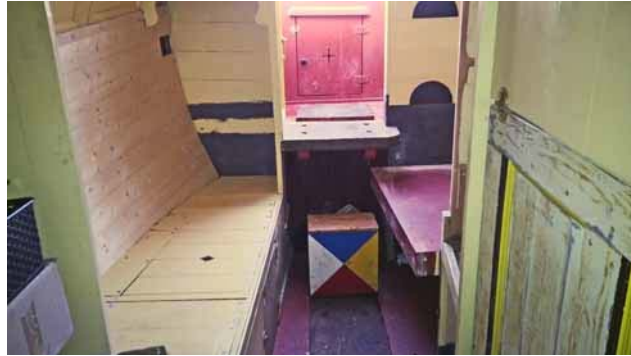
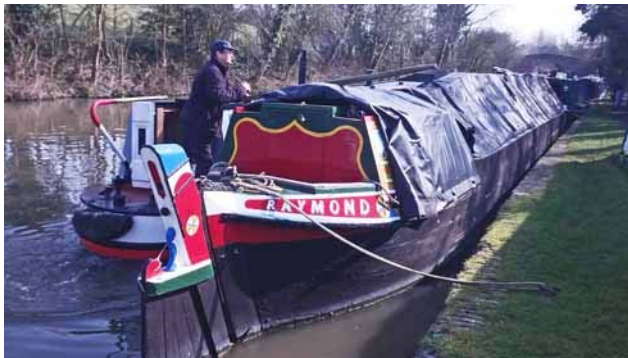
Top right: Pete sets out the deck subframe  
17 February 2018  
Above: the new deck in place  
16 March 2018  
Right: the finished cabin  
Below: Pete brings *Raymond* back  
25 March 2018

In spite of the cold weather, over the three months from January to March, Pete repaired all the rot in the structural timbers, laid new floorboards, fitted new sheering and tongue and groove lining to the sides of the cabin, and constructed and installed a new deck in the hatches. The work was completed and the cabin furniture replaced by the end of March and *Raymond* was returned to the marina just in time to be docked.

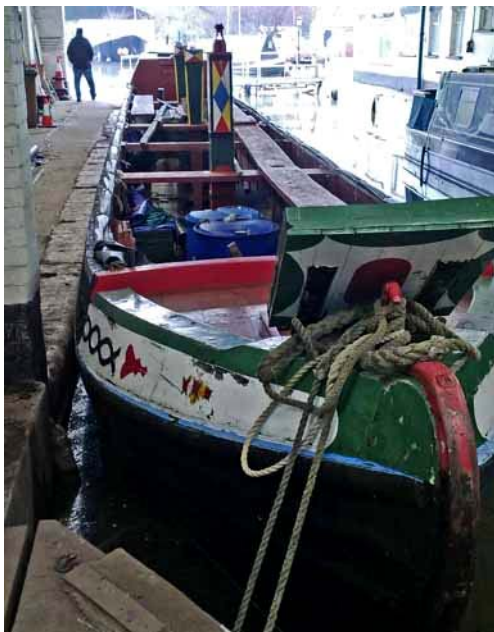
*Raymond* in the wet dock, 31 March 2018

In the first week of April, *Raymond* went into the Braunston Marina wet dock, where a team of FoR volunteers took the cloths off, cleared out the hold, dug out and filled the rot in the woodwork at the fore end and prepared it for painting in readiness for the dry-docking at the weekend.

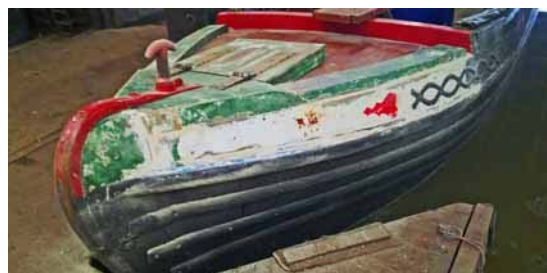
The fore end ready for painting, 5 April 2018

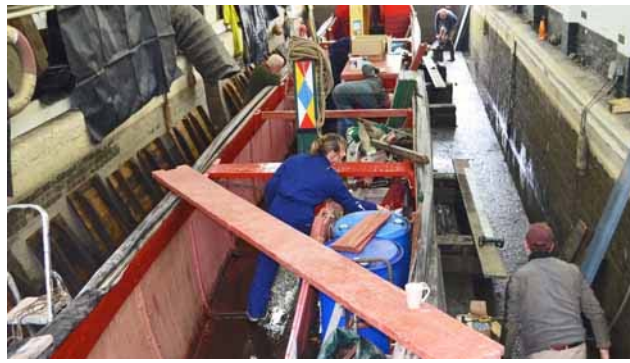
Raymond in the dry dock, 7 April 2018. Picture: Diana Golder

Between Friday 6th and Sunday 8th April, we lifted the shuts and treated them with wood preserver, retouched the paintwork on the cabin, painted the new woodwork in the hatches and all the top planks and beams, and caulked and blacked the hull. At the same time, Bates Boatyard staff fitted new, protective chine shoe plating to the bottom edge of the hull, and Will Hewitt painted and decorated the fore end.

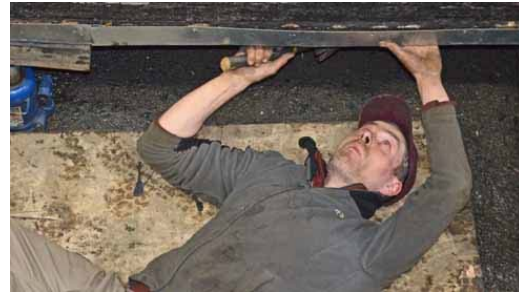
Scott from Bates Boatyard fits the chine shoe plating  
7 April 2017. Picture: Diana Golder

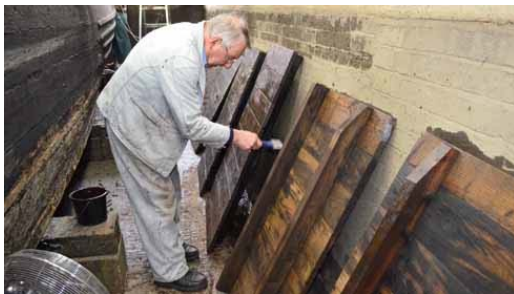
Roger Golder treats the shuts  
7 April 2018. Picture: Diana Golder

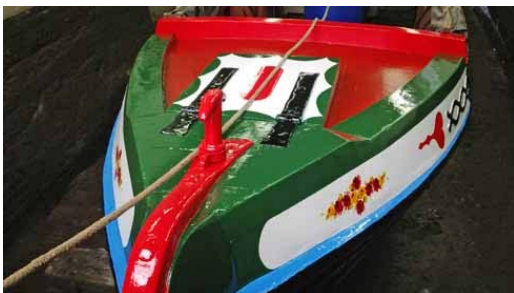
The fore end repainted, 9 April 2018

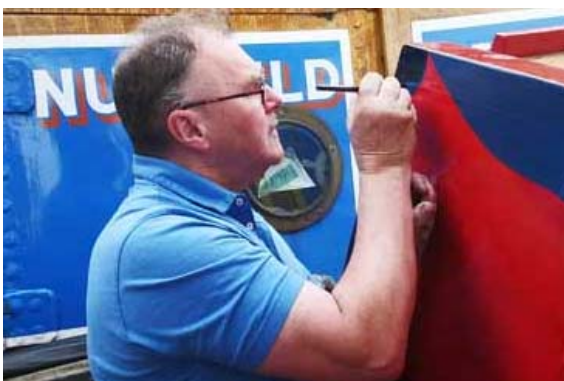
Peter applies black gloss to the scallops, 4 May 2018

Peter added a pattern of black scallops to the cabin's forward bulkhead, which we had discovered from archive pictures was a feature of the original colour scheme.

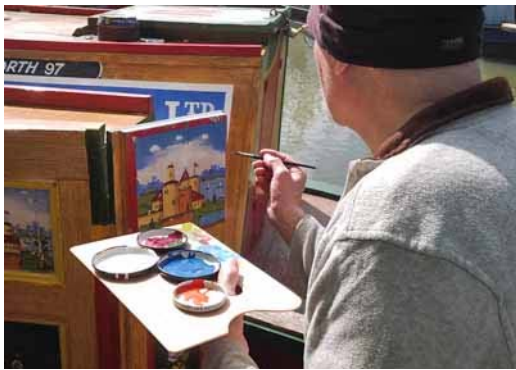
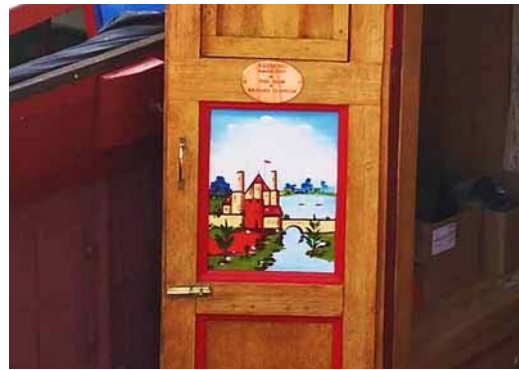
Chris restores one of Ron Hough's original castles (left) while his own version (right) makes a bold statement on the newly-scumbled cabin door into the hold, 4 May 2018.

Chris retouched Ron Hough's castles on the door panels and painted roses in some of the panels inside the cabin.

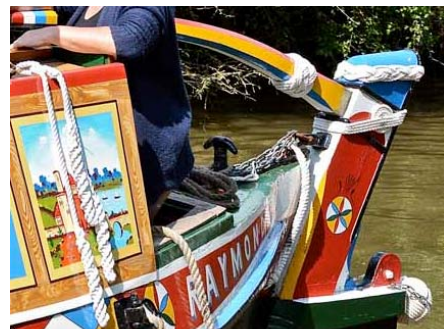
Picture: David Williams

The set was designed to exactly match the style of the ropework on *Raymond* in the 1960s and the picture (right) shows just what an excellent job it was.

As the final touch to complement the paintwork and decoration, *Raymond* was also given a new set of white, decorative ropework.

The various pieces had been made over the winter by Karen Flockhart at Tradline Rope and Fenders, and Pete Flockhart fitted them in time for the photoshoot on 13th May (as reported in the March 2018 issue of FoR News).

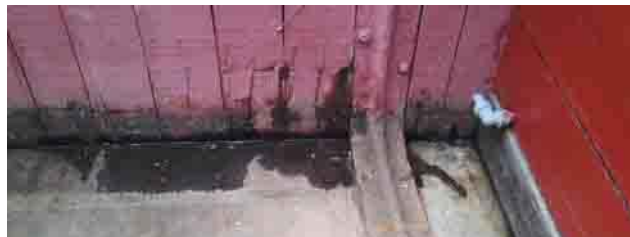
The long, hot spell in mid-summer helped to completely dry out the moisture that usually lies in the bottom of the boat. And this revealed the unwelcome sight that *Raymond's* hull was now leaking. The obvious leak appeared to be between the first plank and the bottoms. And as water was still accumulating under the cabin floor even though the weather had been dry for weeks, it looked most likely that leaks were occurring in several places. It was clear that the only way to fix the problem was to put *Raymond* back into dry dock.

Evidence of the leak, 20 July 2018

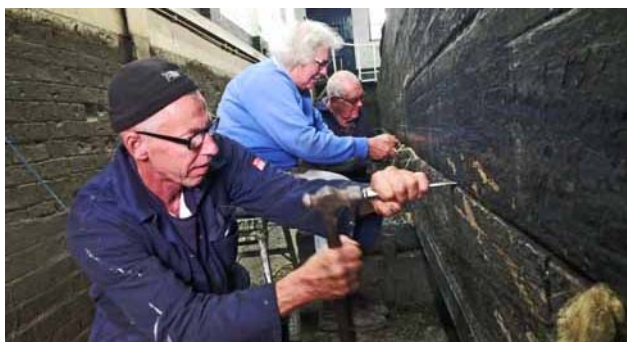
Norman Townsend, Diana Golder and Mike l'Anson caulk the seam between the first and second planks, 3 October 2018

We were aiming to do no more than caulk the two lowest seams, but as soon the boat was clear of the water, we could see that the old chine shoe plating, that had been left on when the new plating was fitted in April, was partially covering the bottom seam and would

have to come off. Unfortunately, that would need more than two days, so all we could do was caulk the seam between the first and second planks which, though a job well done, did not solve the problem.

We have booked a block of six days in the dry dock in early July to give us time to get the job done, and have asked wooden boat expert Adrian Polglase to oversee the work to ensure it is done correctly.

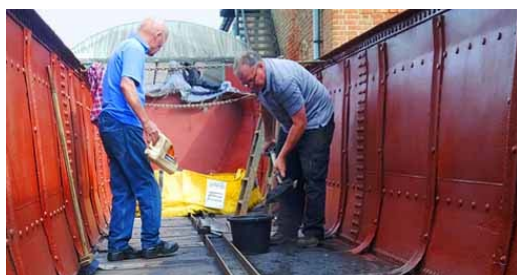
FoR's Robin Bishop and Peter Copeland shovel up the last of the grit, 24 August 2017.

Then, with a bit of volunteer labour to help remove the shuts and the ballast barrels, the hold was grit-blasted and the sides sprayed with two-pack. And with some further volunteer help to shovel out the grit and clean up the hold so the bottom could also be painted, the job was finished by the end of the month.

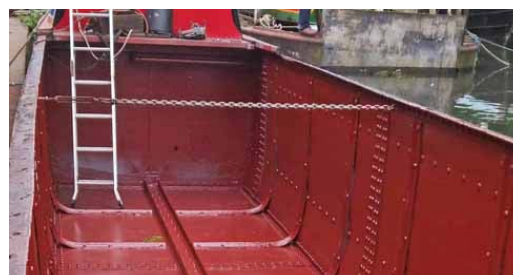
The job finished, 24 August 2017. Note the kink in the left-hand gunwale (see below)

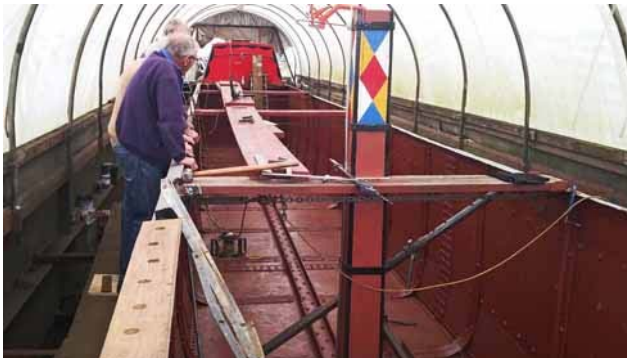
In early September, *Nutfield* was moved into the dry dock at Stretton for the work to begin. But with the old gunwales removed, it was found that the hull and the “gunwale angles”, the steel flanges to which the wooden gunwales are attached, had become too distorted for the new woodwork to be fitted properly so the steelwork would have to be straightened out first.

*Nutfield* in the dry dock at Stretton Wharf, 27 September 2017

By means of a combination of jacks to push the sides of the boat outwards, and clamps and the bracing chains to pull the sides inwards, *Nutfield* was eventually brought back into an acceptable shape.

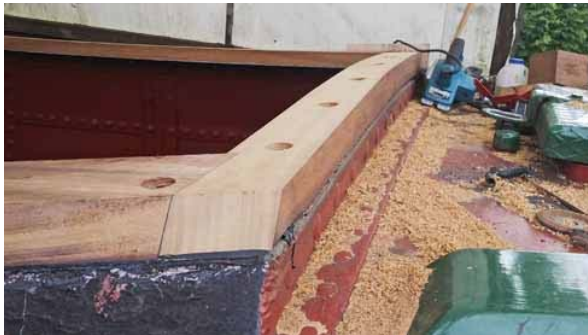
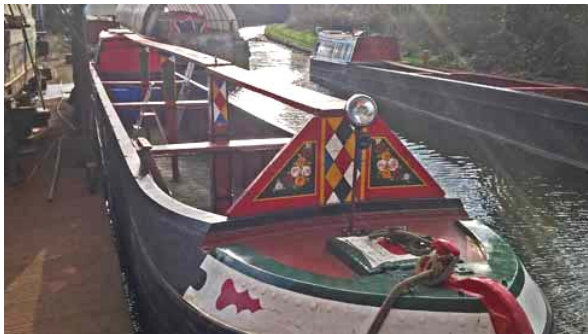
The picture on the left was taken soon after the work of fitting the gunwales had begun. In the foreground, the first length of timber has been bolted to the gunwale angle and one of the jacks is still in place applying pressure to the gunwale angle on the other side.

Top: Detail of new gunwales and deck beam, 27 Sep 2017  
Bottom: Ready for side cloths, 23 Nov 2017

To save costs, more volunteer effort was called upon for the menial tasks such as sweeping up the sawdust and wood shavings in the hold, treating and painting the new gunwales and painting the beams and top planks. By mid-November *Nutfield* was ready to have the side cloths fitted, and everyone agreed that the result was a beautiful job.

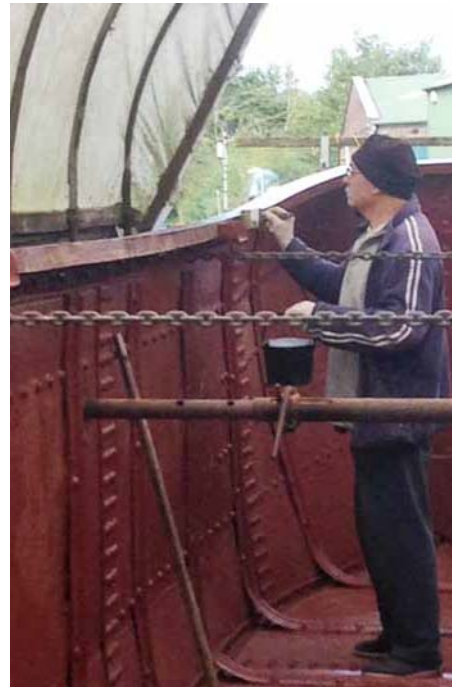
Chris M Jones treats the gunwales with wood preservative, 7 Oct 2017. Picture: Chris R Jones

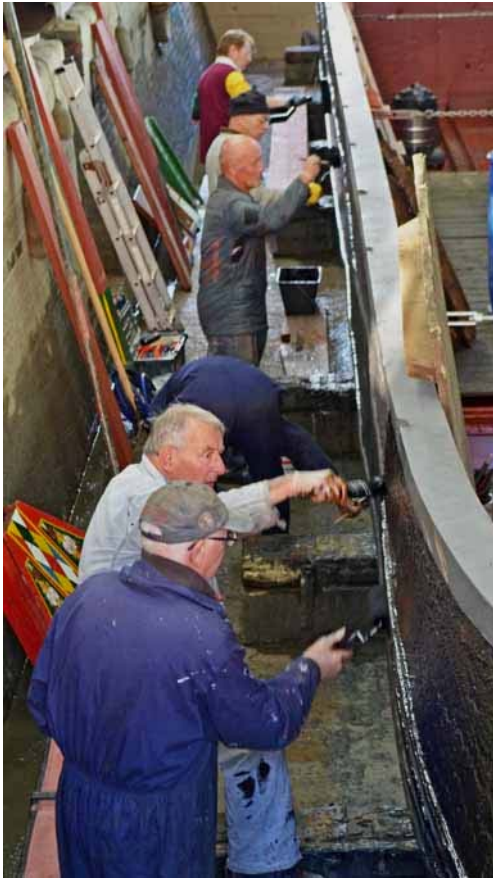
Team work: blacking *Nutfield*, 30 Sep 2018.  
Picture: Diana Golder

Between the morning of Friday 28th September and the evening of Monday 1st October, we rubbed down, undercoated and scumbled the roof of the cabin and engine room, lifted the shuts, replaced sections that were rotten and treated them all with wood preserver, cleaned out the engine bilge and tidied the engine room, touched up the top planks, beams, mast box and gunwales, and blacked the hull.

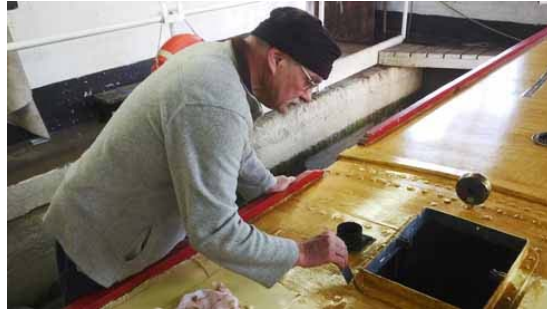
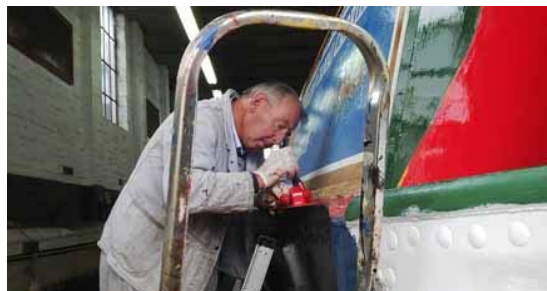
Top: Chris M Jones scumbles the roof, 29 Sep 2018.  
Bottom: Roger Golder paints the gunwales, 30 Sep 2018

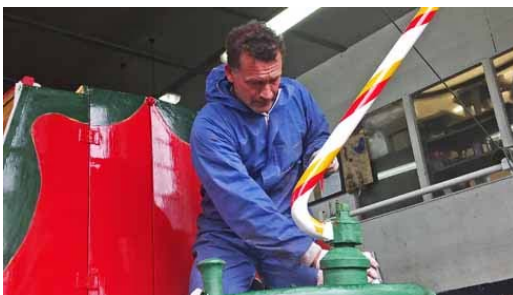
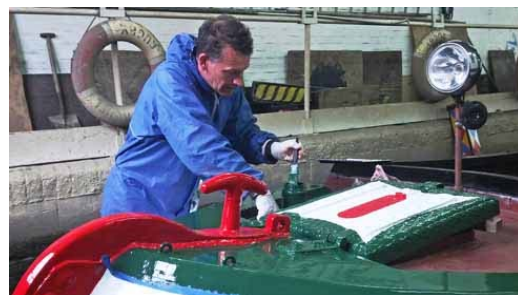
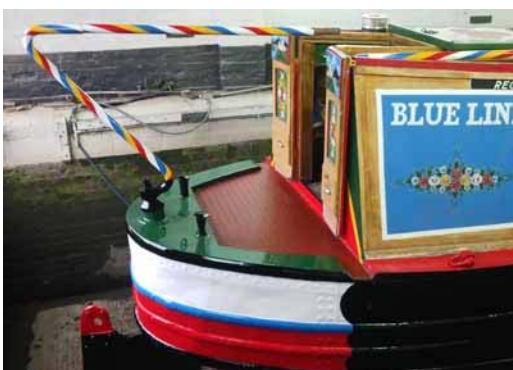
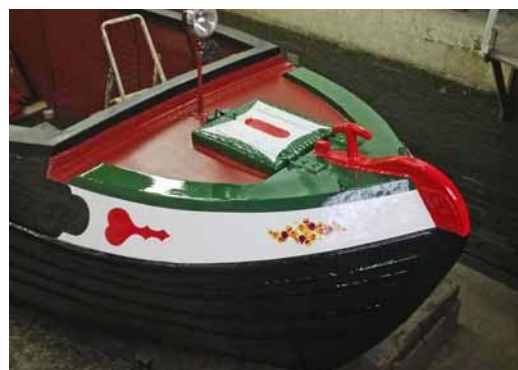
Top left and right: Will Hewitt at work on *Nutfield*, 30 September 2018  
Bottom left and right: The finished result. 2 October 2018

Meanwhile, Will Hewitt painted the back and fore ends of *Nutfield*, including the addition of bunches of roses on the top bends so that, once again, we have a pair with matching fore ends in the traditional Barlow's/Blue Line style.

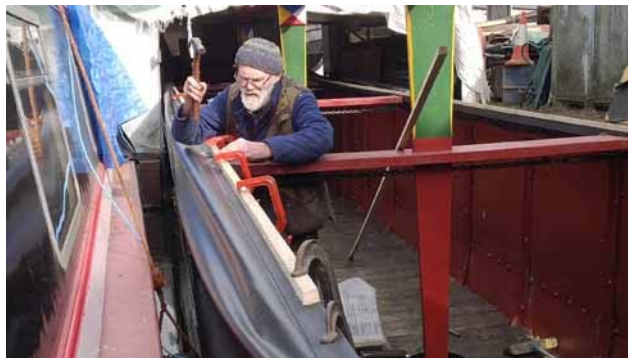
Rex Wain fitting the side cloth, 19 February 2019

The side cloths were finally delivered in January, so we returned *Nutfield* to Stretton on Saturday 9th February for Rex Wain to fit them.
